CODE 45

OXYGEN SENSOR CIRCUIT (RICH EXHAUST INDICATED) 4.3L "B/G" SERIES (TBI)

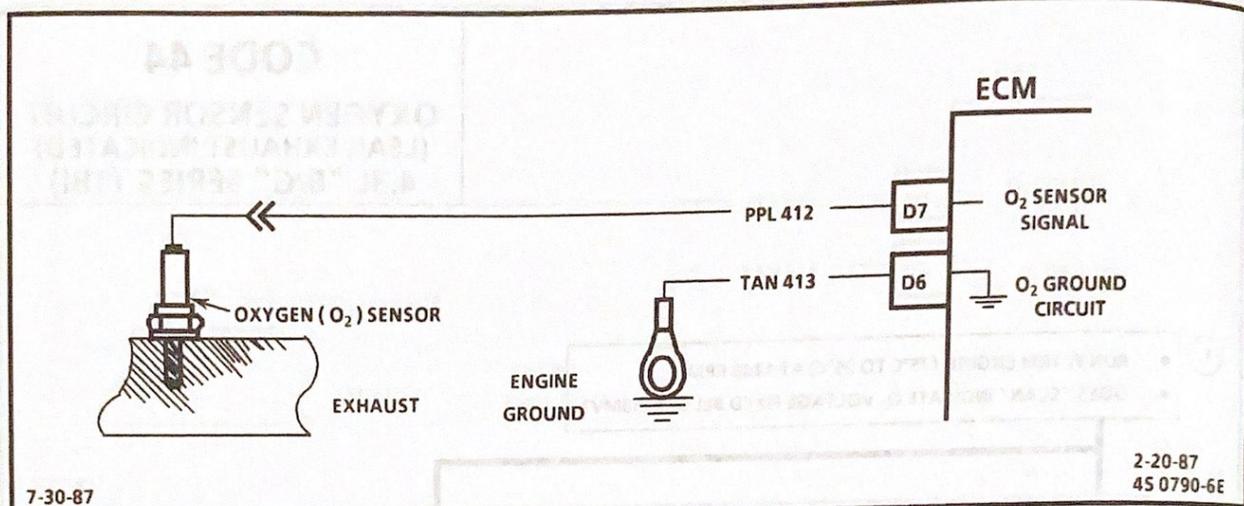
Circuit Description:

The ECM supplies a voltage of about .45 volt between terminals "D6" and "D7". (If measured with a 10 megohm digital voltmeter, this may read as low as .32 volts.) The O₂ sensor varies the voltage within a range of about 1 volt if the exhaust is rich, down through about .10 volt if exhaust is lean.

The sensor is like an open circuit and produces no voltage when it is below about 360°C (600°F). An open sensor circuit or cold sensor causes "Open Loop" operation.

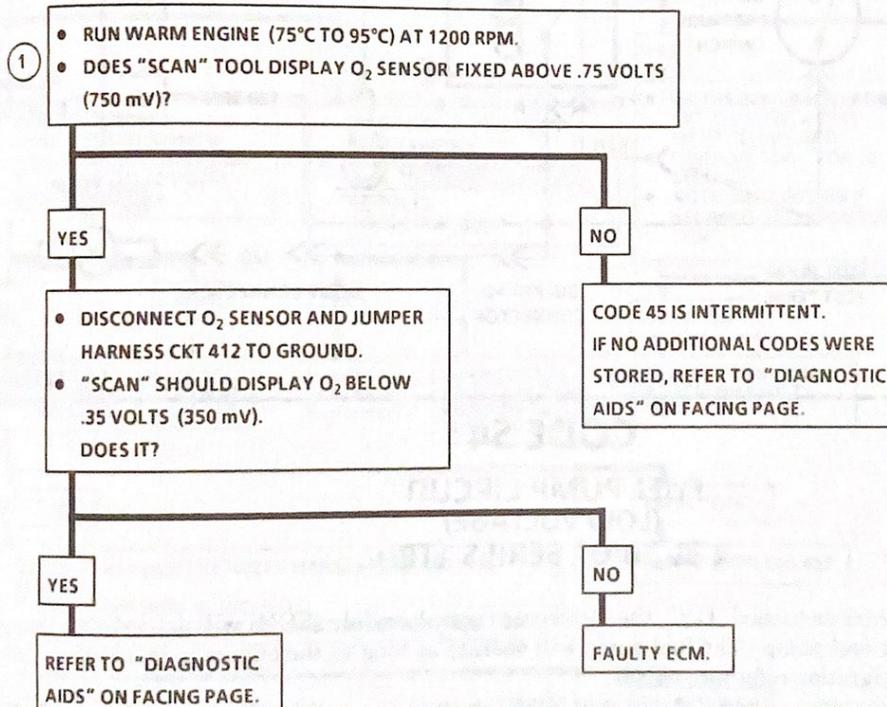
CODE 45
OXYGEN SENSOR CIRCUIT
(RICH EXHAUST INDICATED)
4.3L "B/G" SERIES (TBI)

Test Description: Numbers below refer to circled numbers on the diagnostic chart.

- Code 45 is set when the O₂ sensor signal voltage or CKT 412.
 - Remains above .7 volt for 50 seconds; and in "Closed Loop".
 - Engine time after start is 1 minute or more.
 - Throttle angle greater than 2% (about .2 volts above idle voltage) but less than 25%.

CLEAR CODES AND CONFIRM "CLOSED LOOP" OPERATION AND NO "SERVICE ENGINE SOON" LIGHT.
